INDOOR AIR QUALITY ASSESSMENT

**Brockton City Hall
45 School Street
Brockton, Massachusetts**

Prepared by:
Massachusetts Department of Public Health
Bureau of Environmental Health Assessment
June, 2002

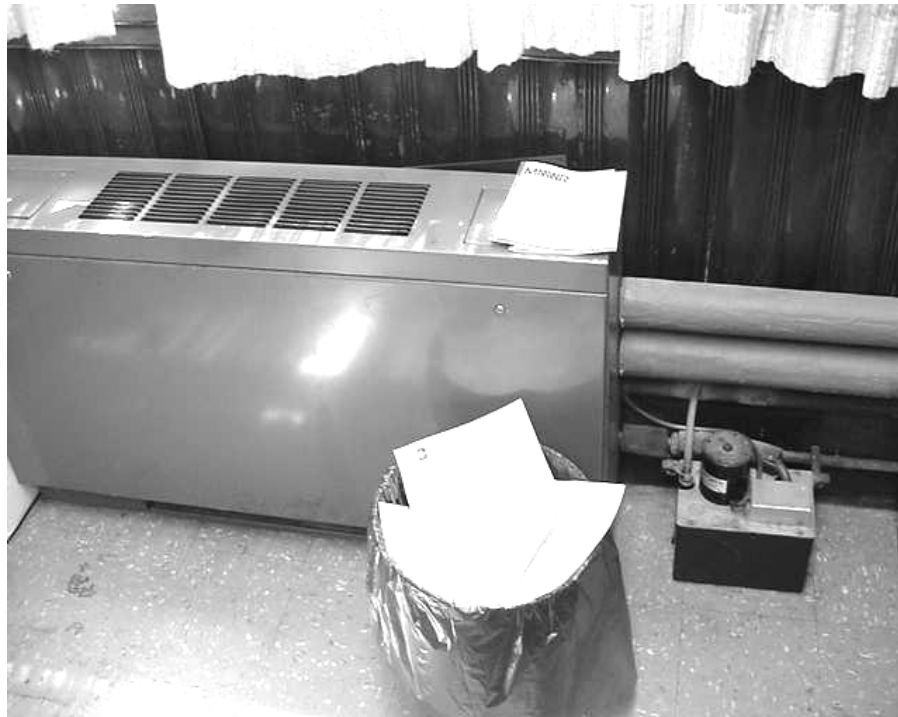
Picture 2

Each room with windows is equipped with a fan coil unit (FCU) (see Picture 2). Each FCU is located on exterior walls underneath windows. The purpose of the FCU is to provide heating or cooling by circulating air. The FCUs are incapable of introducing fresh outdoor air. The FCU draws air from the room through a filter in the base of the cabinet into fans. Fans force air through coils that heat or chill the air. Conditioned air exits the FCU through fixed louvers on the top of the cabinet. FCUs were not operating in most offices evaluated. Some FCU are blocked with office furniture and other items, which can hinder the operation of this equipment.

Typical FCU in BCH Office

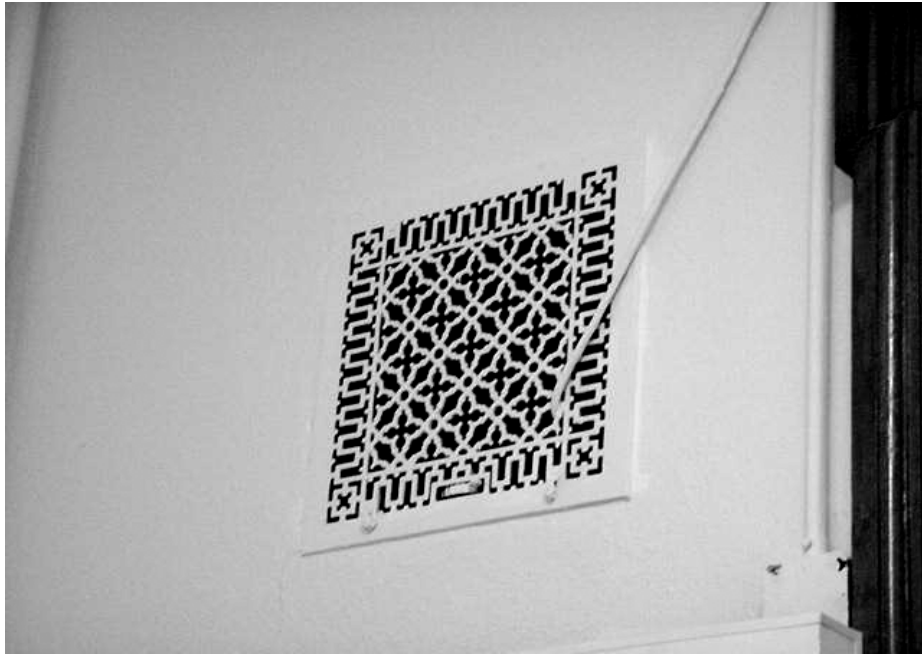
Picture 3

Each office area appears to have an exhaust ventilation system (see Picture 3). The exhaust grilles appeared to be connected to an exhaust fan located in the attic. The attic exhaust vent was disconnected from its original roof terminus and its motor was removed. The fan housing stands open in the attic and now serves as a pathway for attic air to migrate into offices. Further, without mechanical exhaust ventilation normally occurring environmental pollutants may accumulate in offices. In this configuration, the BCH does not have an operational ventilation system that could introduce fresh air or provide exhaust ventilation.

Exhaust Vent in Wall

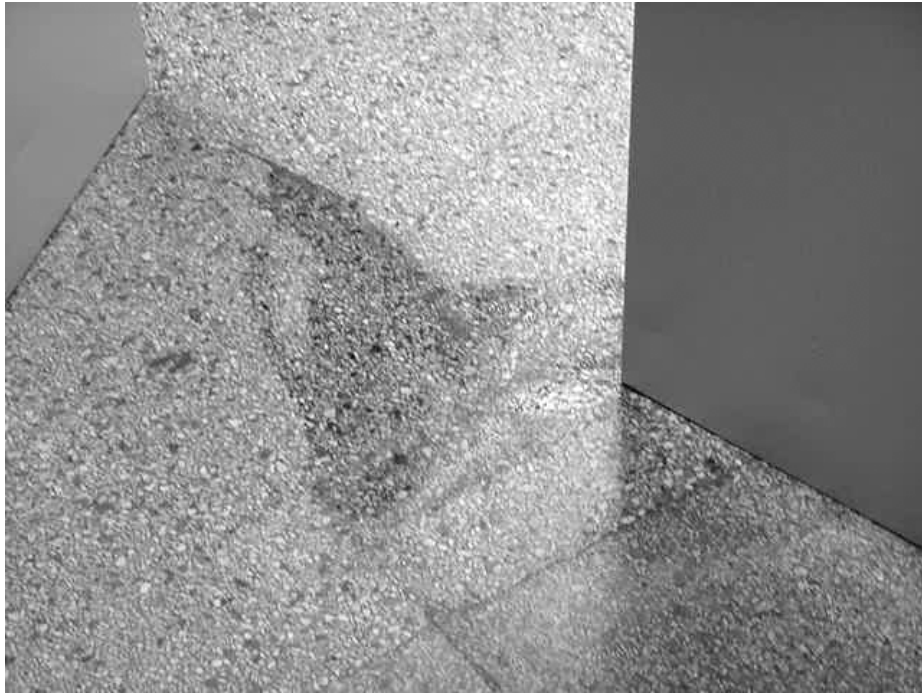
Picture 5

Concerns about moisture accumulation in the Brockton Health Department office (BHDO) were the primary focus of this assessment. Office occupants reported musty odors in this area. An accumulation of moisture was noted underneath file cabinets near a door threshold that leads to the back offices (see Picture 5). Moisture samples were taken in carpet and wood in and around the floor. Wood of the doorframe and coving had normal moisture readings (< 15%). Wood of the threshold had a moisture content greater than the other wood sampled (>15% water concentration), indicating it may be moistened by a water source within the building. The threshold was removed, which released a strong musty odor near the floor.

Water Accumulation Noted in BHDO

1. Remove the false floor in all basement offices.
2. The building was designed to use windows to provide fresh air. Since no mechanical ventilation is available, the opening of windows is recommended to temper room temperature and provide fresh air during the **heating season only**. Opening windows during hot weather during summer months will introduce moisture into the building, resulting in condensation generation on chilled water pipes during operation of the chiller.

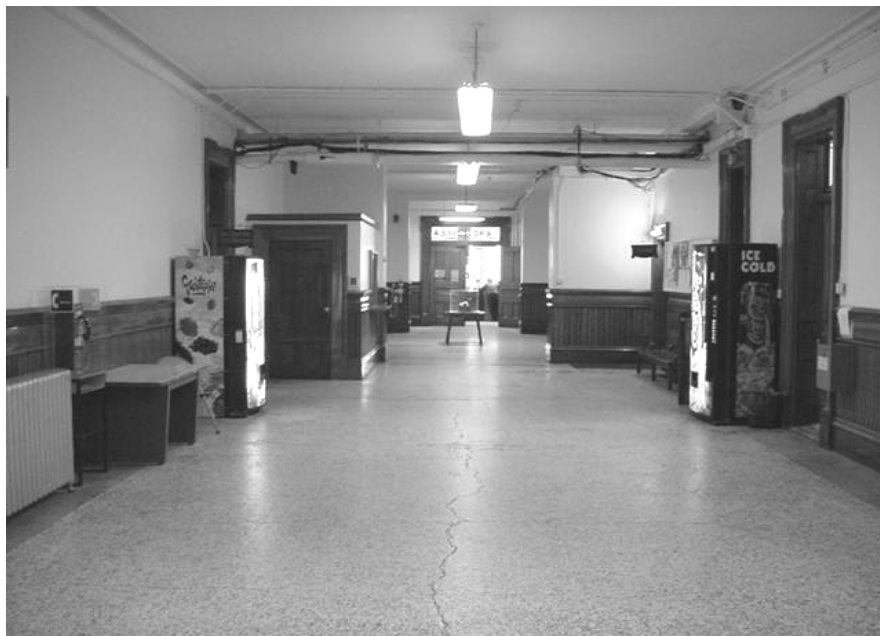
Picture 6

The floor in the basement is made of stone and tiles in offices (see Pictures 6 and 7). An elevated floor was installed in basement offices on top of the stone/tile floor. This installation created a cavity, through which uninsulated pipes for the heating system exist. This configuration creates conditions in the floor space to generate condensation.

Floor In Basement Hallway

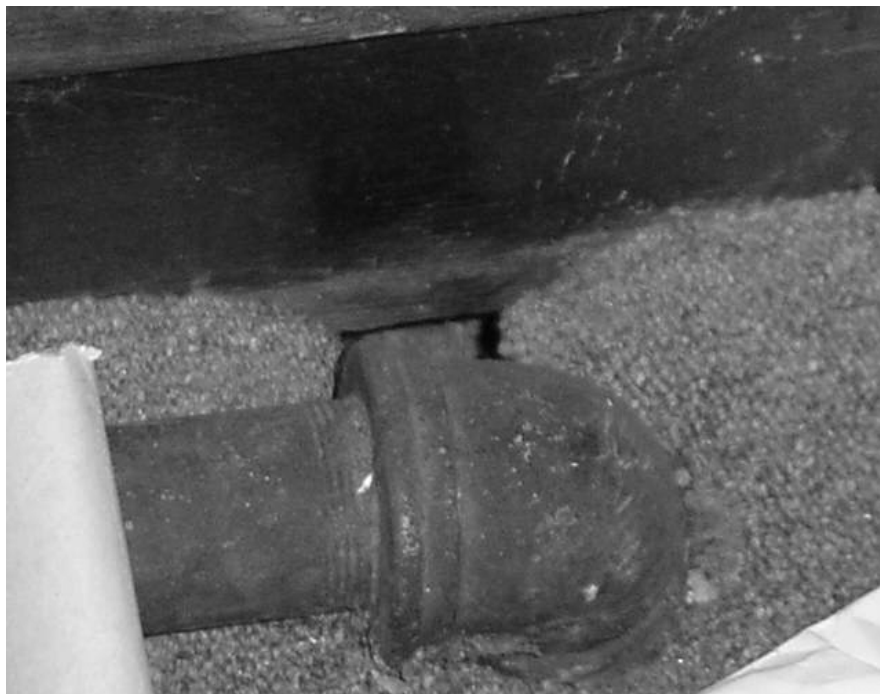
Picture 7A

Heating Pipe Entering False Floor In BHDO, Note Lack Of Insulation

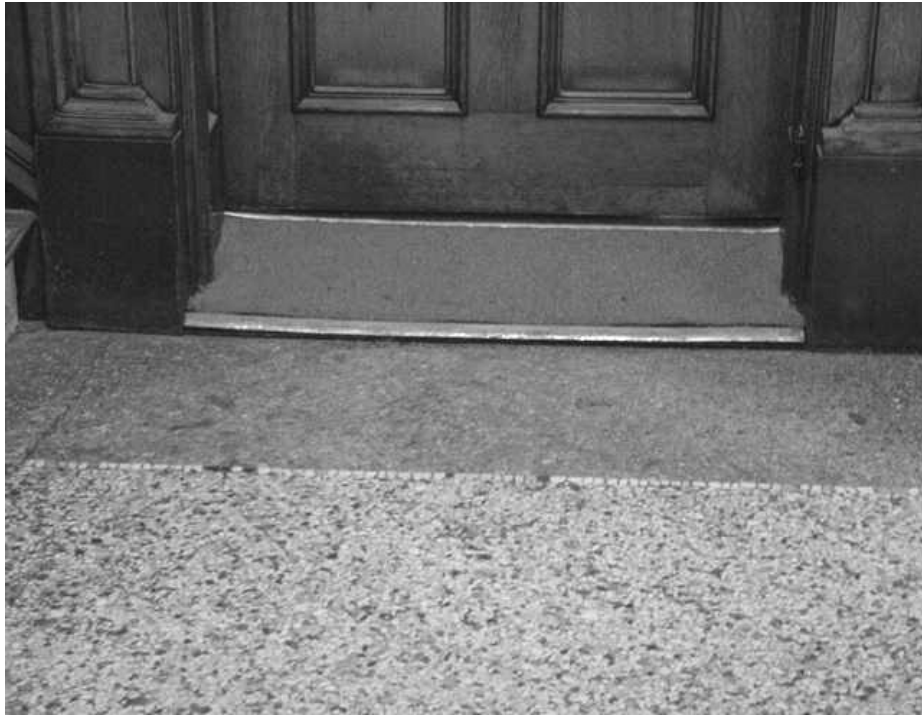
Picture 7B

As discussed, the BHDO is not the only basement office that experiences water pooling. The tax office experiences water accumulation near a hallway door in close proximity to an uninsulated heating pipe (see Pictures 7B and 7C). Occupants in the assessor's main office report wood rot to the point where the floor was removed. No signs of water damage appeared in carpeting or other materials in the assessor's office. Occupants report that no further signs of water generation exist in this area since the removal of the false floor.

Threshold of Tax Office Door (Room 5) that is Prone To Water Accumulation

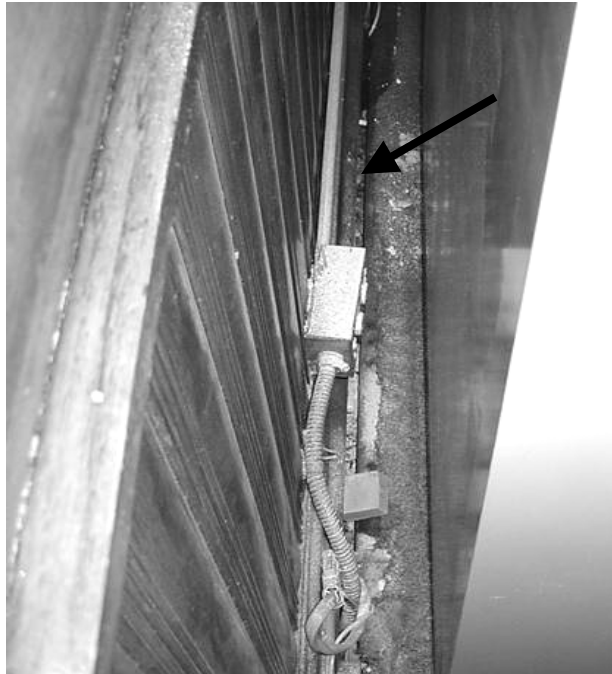
Picture 7C

Uninsulated Heating Pipe near Door Threshold of Tax Office (Room 5)

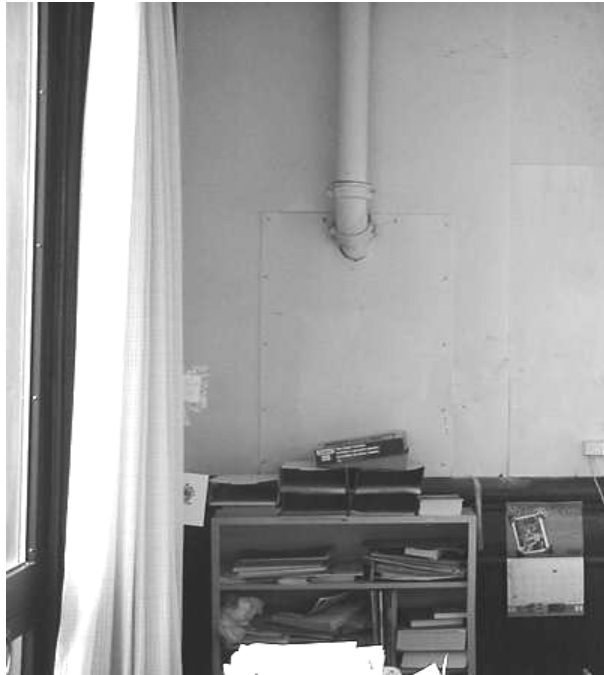
Picture 9

1. Several incidents were reported by building occupants of oil and solvent odors penetrating into the BHDO from the boiler room during use.
2. BEHA staff detected of musty odors in the boiler room and similar odors in the BHDO around a pipe (see Picture 9) that penetrates into the catacomb.

Pipe In BHDO That May Be Odor Pathway From Catacombs

9. Seal holes in the floors, walls and ceilings for pipes and cables to prevent infiltration of pollutants from wall cavities and the catacomb into occupied areas.

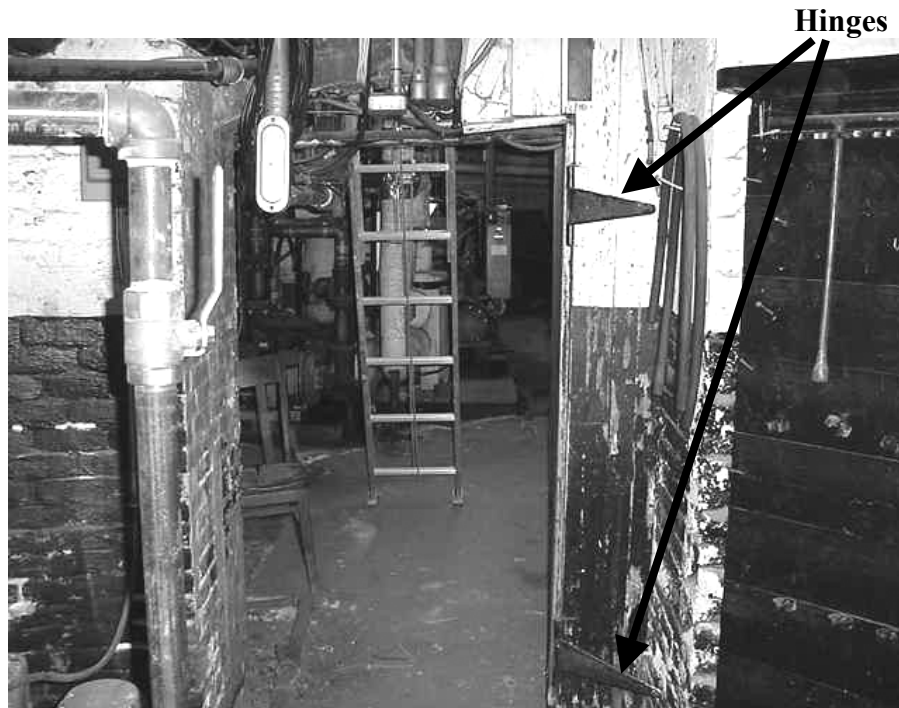
Picture 10

3. BEHA staff identified that same musty odor emanating from a sink cabinet in the tax office.
4. A door separating the boiler room from the catacombs was removed, presumably for installation of electrical conduit (see Picture 10). This door may have reduced the pressurization of the catacombs. Once the door was removed, boiler room air could freely move into the catacombs and then into basement offices through the floor.
5. The door to the boiler room is not airtight nor is it fire-rated. Space around the boiler room door can allow boiler room odors to penetrate into the basement area.

A View from the Catacombs of the Doorway to the Boiler Room, Note the Existence Of Door Hinges, Indicating That A Door Formerly Was Installed Over This Portal

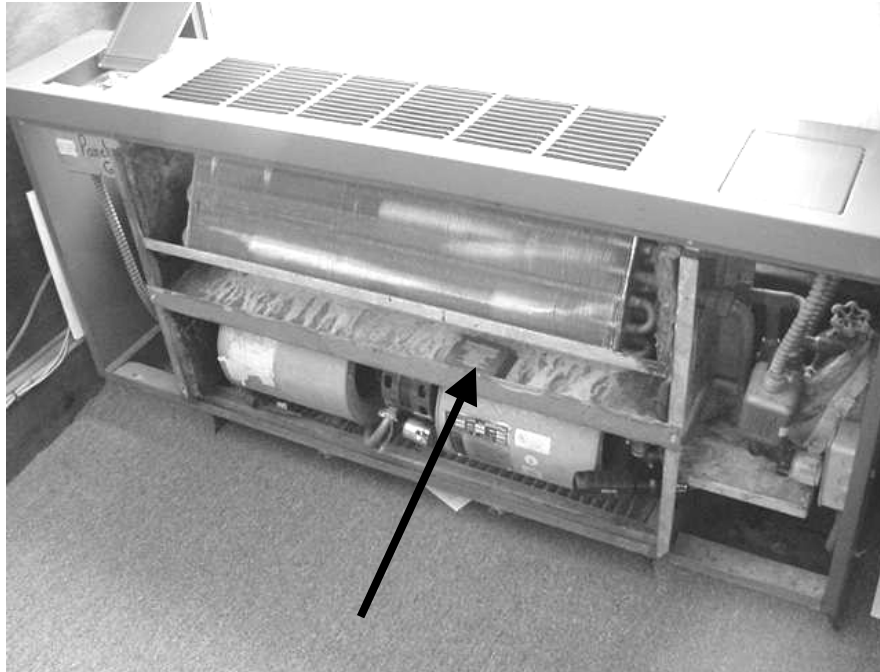
Picture 11

The configuration of drainage as well as the condition of the interior of FCUs may also be a source of microbial growth. Each FCU has the capacity to provide heat and air-conditioning. As FCUs operate in the air conditioning mode, condensation accumulates on the coils as air is chilled. Each FCU has drip pans to collect and drain condensation from cooling coils (see Picture 11). Several units were examined and were found to have drip pans coated with dirt and other debris, which can serve as growth mediums for mold when these units are activated for air conditioning. Several employees indicated that mold odor emanates from the FCUs when activated. The drip pan collectors (see Picture 12) are also coated with dirt and debris, suggesting that these units are not routinely cleaned. In an effort to control microbial growth, a packet of alkaline materials was placed in the drip pan.

Interior of FCU, Note Drip Pan and Box Inside Drip Pan

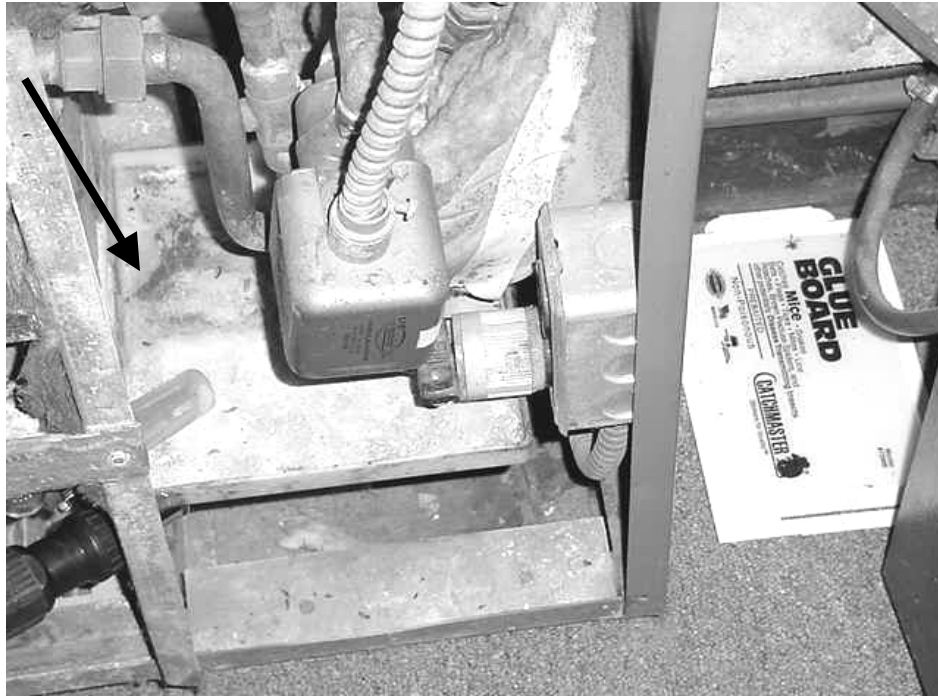
Picture 12

Debris in FCU Drip Collector

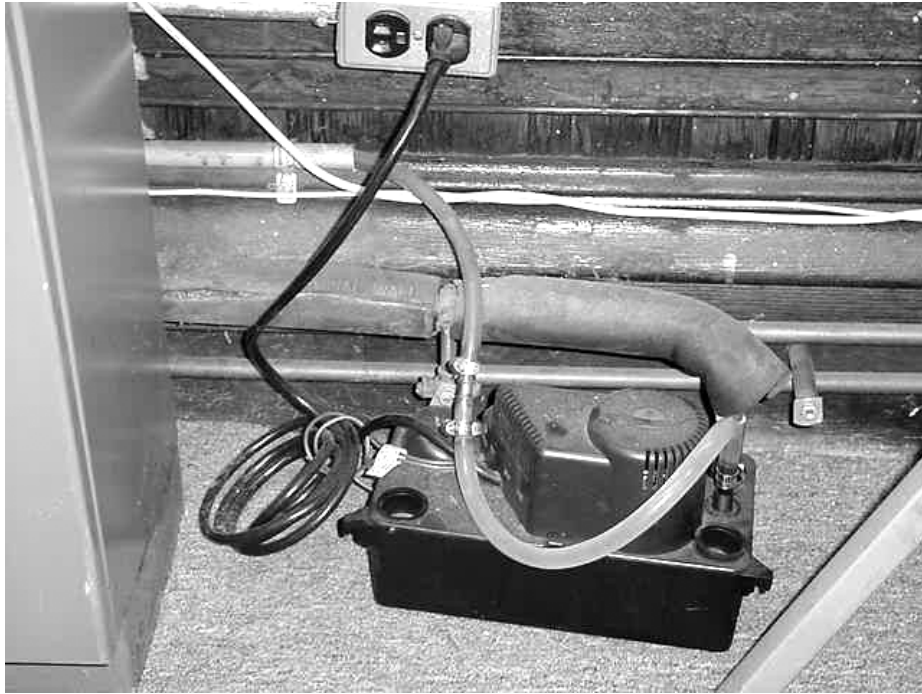
Picture 13

FCUs in basement offices empty into a pump (see Picture 13). The pump is connected by plastic hose to a vertical, metallic pipe [which appears to be reused electrical conduit (see Picture 14)], which is in turn, connected by plastic hose to an existing drain system over ten feet above the FCU. It could not be determined whether the pumps have sufficient horsepower to pump collected condensation from the collectors. This may result in water overflow from the condensation pumps, which can then moisten carpet (see Picture 15).

Condensation Pump For FCU, Note Seams in Insulation and Exposed Metal of Pipes

drain to decrease the distance of pipe. Replacement of condensation pumps with ones with a larger horsepower capacity may be necessary.

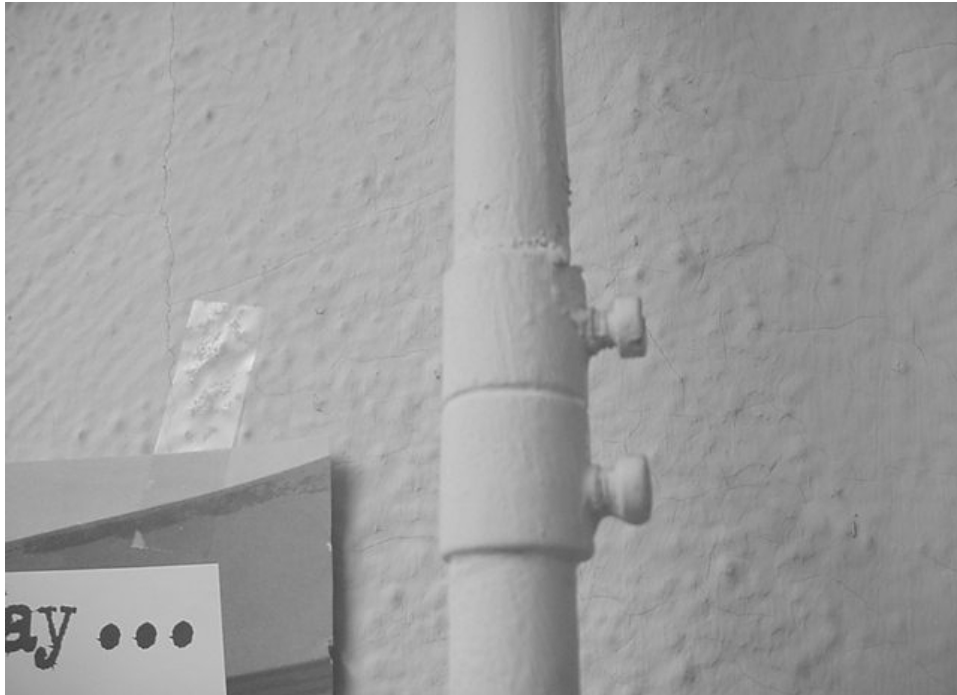
Picture 14

Metallic Pipe Connected To FCU Condensation Drains

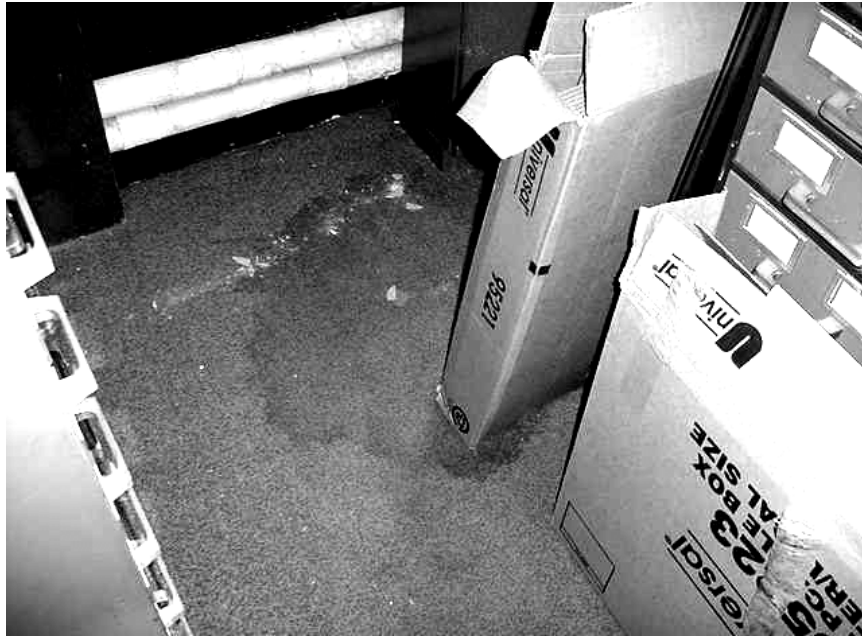
Picture 15

Water Damaged Carpet around FCU Condensation Pump

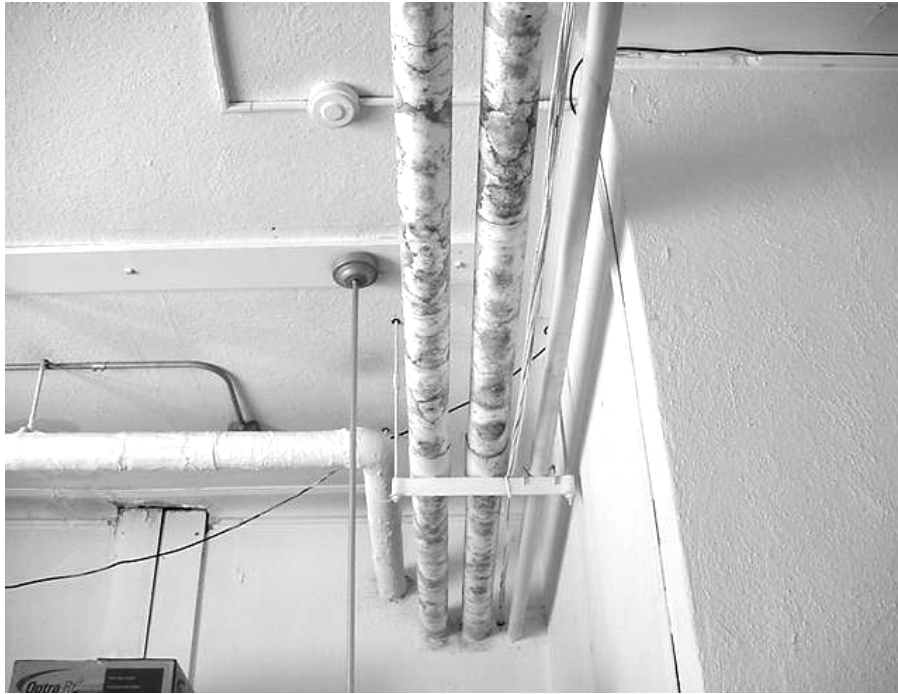
Picture 16

Mold growth was evident on pipe insulation on heating pipes near the ceiling of the mailroom (see Pictures 16). The condition of these pipes may indicate that either insulation has spaces that allow for air to come in contact with the bare pipe or that the insulation does not have a sufficient R rating.

There appear to be several sources of moisture resulting in condensation. Condensation occurs if spaces in the insulation exist or the R rating of the insulation is not sufficient. Spaces between insulation sections can allow for moist air to come in contact with the metal of the chilled water pipes, which creates condensation. The R rating is a mathematical representation of the ability of insulation to prevent temperature transfer. If an air conditioning system has chilled water pipes with an insufficient R rating, temperature could be transferred to the surface paper, thus creating condensation. Once water wets insulation, a temperature bridge is created, which results in further wetting of insulation and enhancing mold growth. In order to cease the continued production of moisture on these pipes, the air conditioning system supplying the chilled water must be deactivated. While the chiller deactivation will prevent the further production of condensation, the reactivation of the chilled water system without taking steps to replace dampened pipe insulation would be expected to result in further water damage and potential mold growth.

Mold Growth on Pipe Insulation

2. Consider restructuring the condensation drains for basement AHU to empty outside the building through window frames.
3. Replace chilled water pipe insulation with a sufficient R rating to prevent generation of condensation on these pipes.

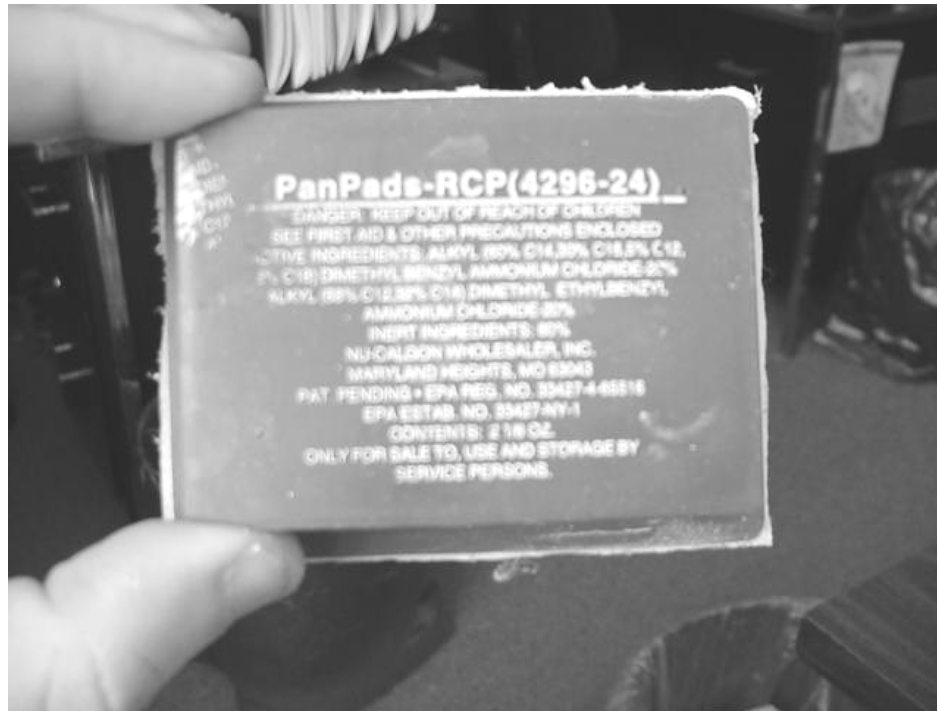
Picture 17

Several additional conditions were noted during the assessment, which can effect indoor air quality. The interiors of a number of FCU were examined. An antimicrobial agent (Pan Pad[®] Condensate Treatment) was found in every drip pan examined (see Picture 17). The product sheets for this material indicate it is to be used as a broad-spectrum antibiotic that also is effective against *Legionella pneumophila* (Nu-Calgon, 2002a). The use of this product in FCU drip pans is unnecessary. In order to support bacteria growth such as *L. pneumophila*, moisture within a temperature range must be

Of note are the constituents of the Pan Pad® product. This product consists of two organic ammonium chloride compounds and borax (disodium tetraborate) (Nu-Calgon, 2002a), all of which are alkaline materials. BEHA staff removed a Pan Pad® from a FCU. The odor produced by this product is characterized as a “mothball-like” odor. As condensation contacts the Pan Pad® surface, a 14% solution of Pan Pad® ingredients is formed in water (Nu-Calgon, 2002b). This solution may become aerosolized during FCU operation if standing water exists in drip pans. This solution may also contaminate carpeting as water overflows from condensation pumps. Exposure to this product may cause irritation to the eyes and skin. BEHA staff has contacted Nu-Calgon to ascertain if this product is being used in conformance with manufacturer’s instructions.

Pan Pad® Condensate Treatment Used in FCU Drip Pans

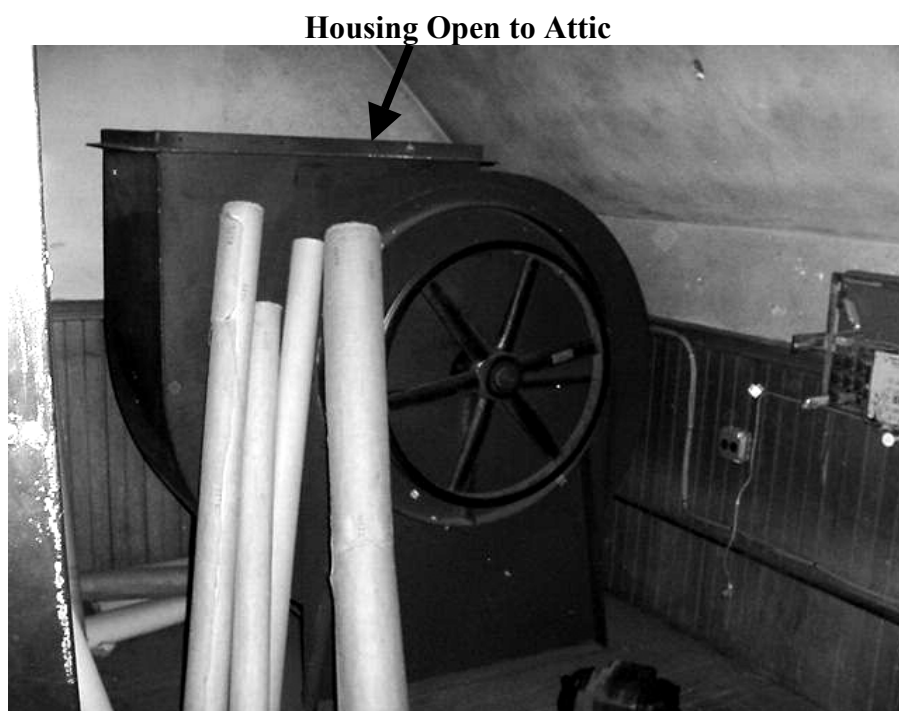
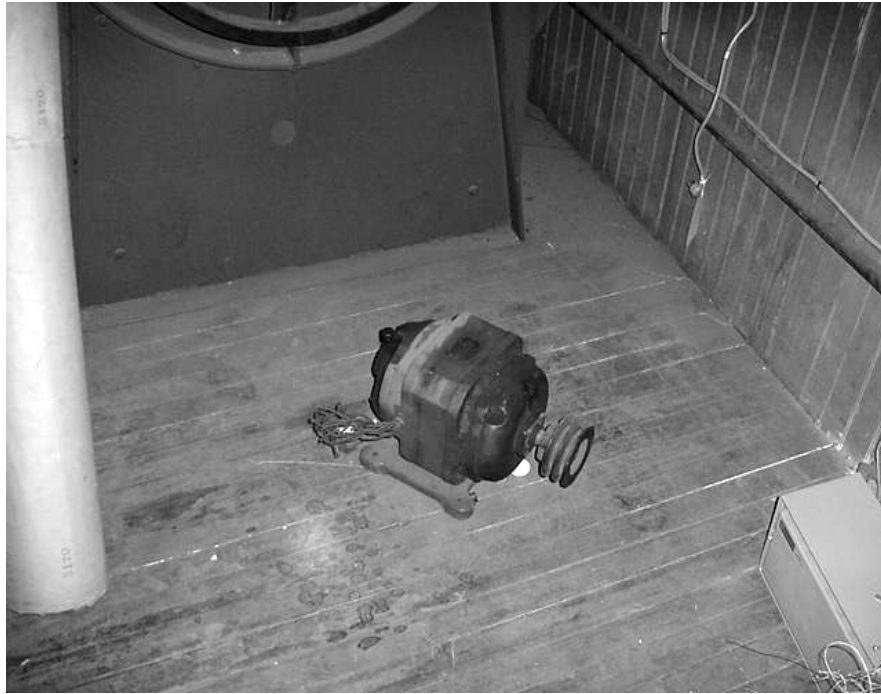
The original exhaust system fan was located in the attic (see Picture 18 and 18A). It appears that this fan was disconnected from the roof when the AHU that services the

interior offices of the engineering department was installed. This system was not abandoned. The original fan duct is open to the attic and all exhaust vents remain open in offices throughout BCH. This pathway may allow for pollutants in the attic to migrate to offices. Some restroom vents are vented into the attic (see Picture 19), which then may migrate to offices via the abandoned exhaust ventilation system.

Disconnected Original Exhaust Vent Fan

Motor For Abandoned Exhaust Fan

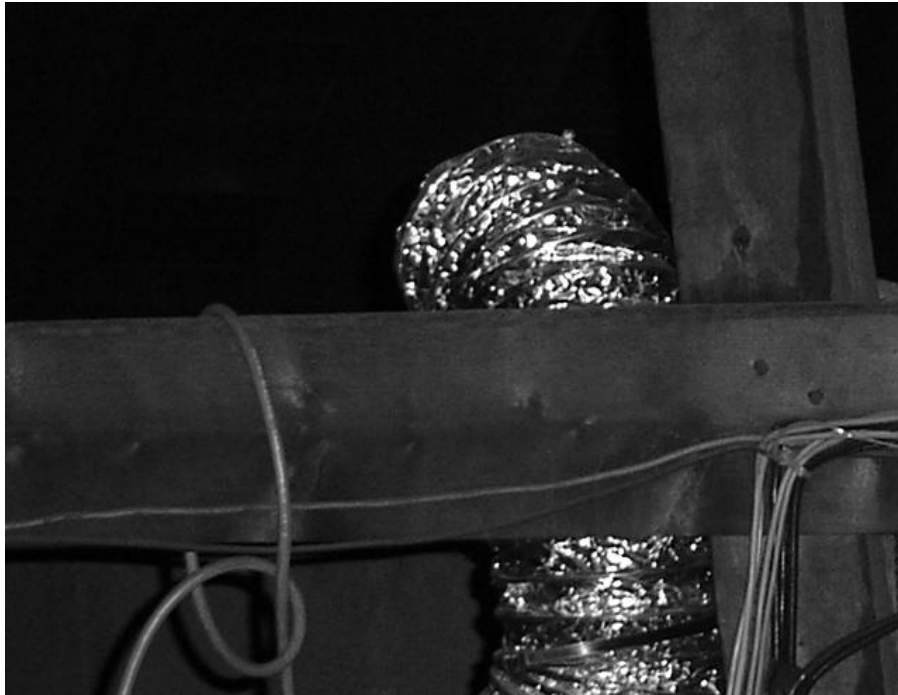
Picture 19

Restroom Vent That Terminates In the Attic

19. Seal hole around chiller pipes in attic to prevent pest infiltration.
20. Install means to vent restroom air outdoors.
21. Examine the drainpipe in the boiler room and determine whether a trap exists. If no trap exists, consult a plumber to consider the best options to prevent sewer gas backup, which may include installation of a drain trap.

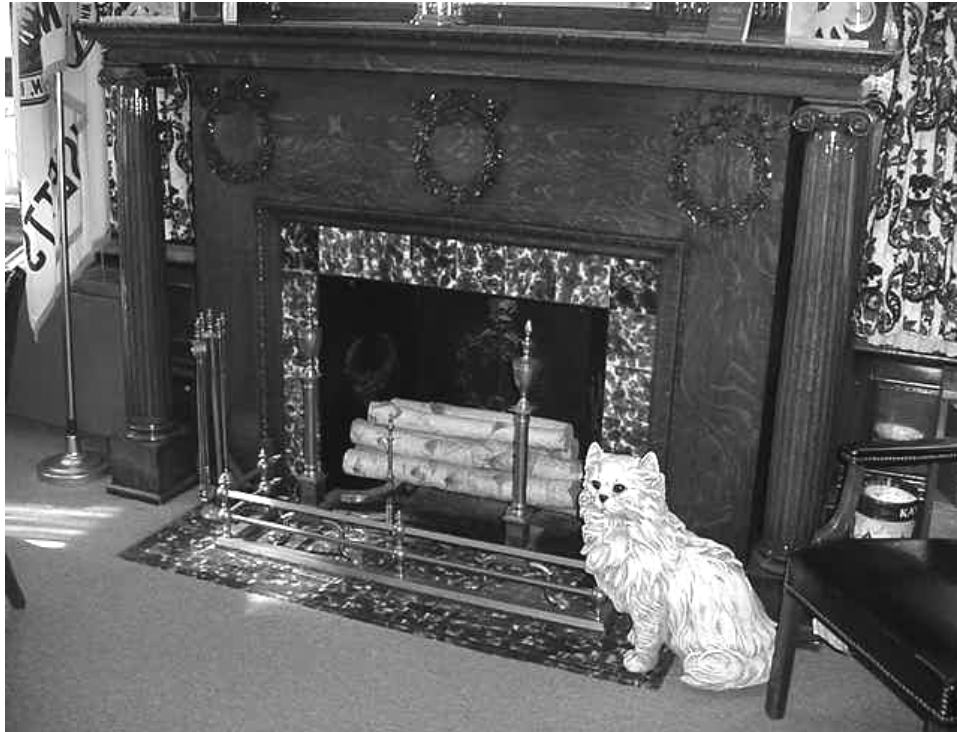
Picture 20

The City Clerk's office contains a fireplace that is no longer in use (see Picture 20). The flue for the chimney is not sealed, which may allow for air to penetrate into this office. The chimney for the fireplace exists on the roof. The top of the chimney is open, which can allow rainwater to penetrate down the shaft. In addition, animals/pests may also enter the building through the chimney.

Fireplace in City Clerk's Office

17. Seal unused chimneys on the roof to eliminate water penetration/pest infiltration. For chimneys still in use, consider installing a chimney cap to prevent rainwater penetration.

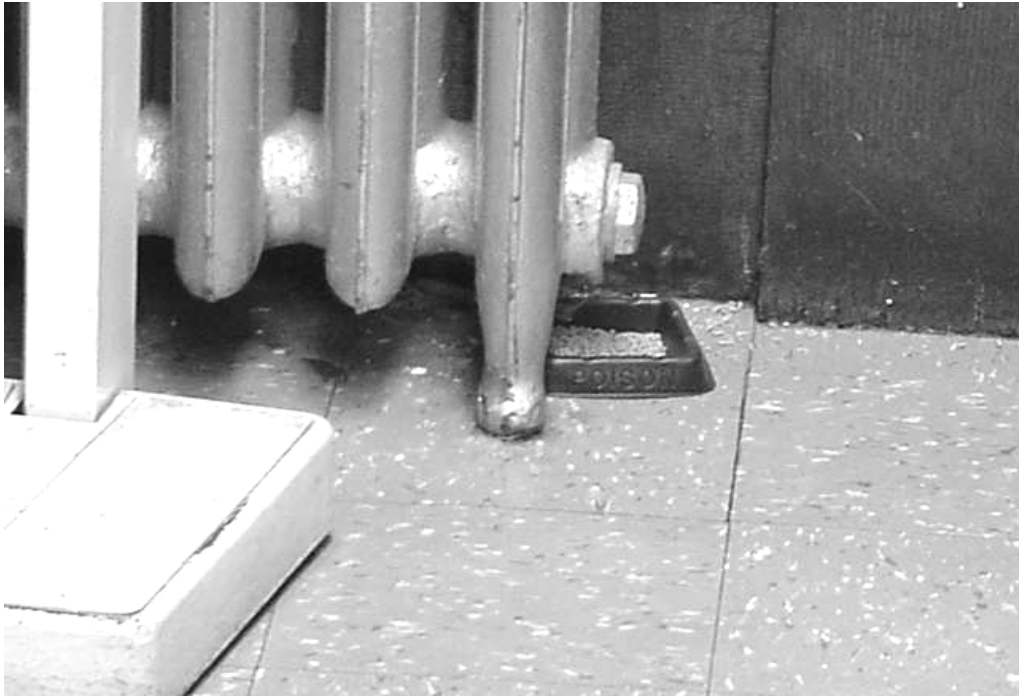
Picture 21

Periodic rodent sightings were also reported to BEHA staff. An open container of rat poison was found beneath the radiator in the public health nurse's office (see Picture 21). Rodent infestation can result in indoor air quality related symptoms due to materials in their wastes. Mouse urine contains a protein that is a known sensitizer (US EPA, 1992). A sensitizer is a material that can produce symptoms readily in sensitive individuals. A three-step approach is necessary to eliminate rodent infestation:

Open Container of Rat Poison in Public Health Nurse's Office
